Maryland Inventory	y,of Historic Properties number:_	M:25-26
		HOUSE PROVOULA AMS PR

NAME AND SHA NO.: M- 021

LOCATION Road Name and Number: Piney Meetinghouse Road over Watts Branch City/Town: Rockville X vicinity Montgomery
Ownership: _ State X County _ Municipal _ Other
Bridge projects over: _ Road _ Railway X Water _ Land
Is bridge located within designated district?: _ yes _X no NR listed district _ NR determined eligible district locally designated _ other Name of District _
BRIDGE TYPE
Timber Bridge Beam Bridge Truss-Covered Trestle Timber-and-Concrete
Stone Arch Bridge
Metal Truss Bridge
Moveable Bridge Swing Bascule Single Leaf Bascule Multiple Leaf Vertical Lift Retractile Pontoon
Metal Girder Rolled Girder Rolled Girder Concrete Encased Plate Girder Plate Girder Concrete Encased
Metal Suspension
Metal Arch
Metal Cantilever
X Concrete Concrete Arch Concrete Slab X Concrete Beam Rigid Frame Other Type Name 585

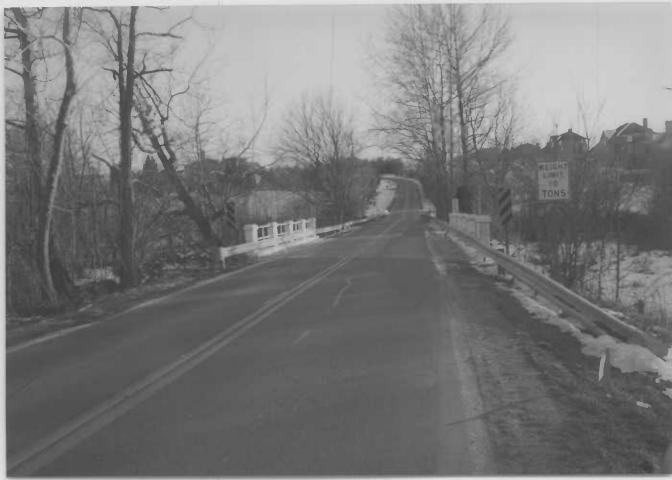
Name M21-PINEY MEETING HOUSE OVER WATTS BRANCH
County/State MONTGOMERY / MP
Name of Photographer FRANK JULIANO
Date 2 95
Location of Negative SHR
Description SOUTH APPRDACH
Number K of 36 4

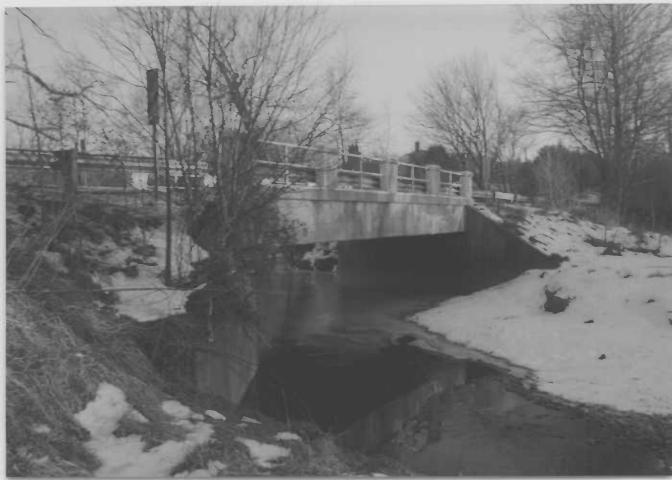
Name M21-PINEY MEETING HOWE OVER WATTS BRANC
County/State MONTGOMERY MO
Name of Photographer FRANK JULIANO
Date 2/95
·
Location of Negative SAR
Description ELEVATION LOOKING EAST
•
Number 5 of 26

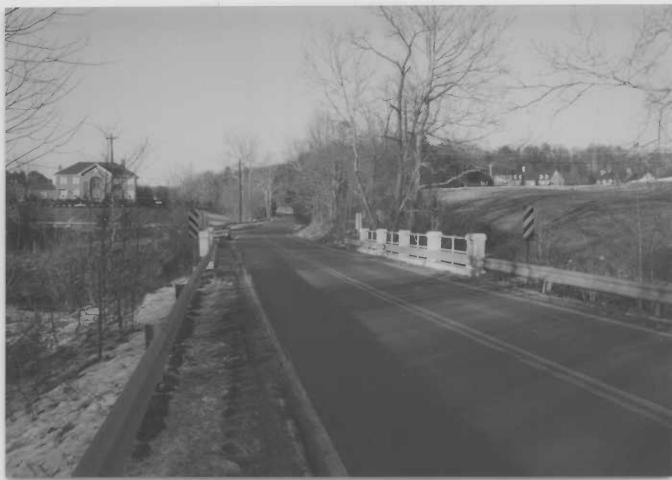
Name M21 - A NEY MEETING HOWE OVER WATTS BRANCH
County/State MONTOOMERY MO
Name of Photographer FRANK JULIANO
Date 7 95
Location of Negative SHR
Description MORTH APPROACH
Number of Sta
Number of

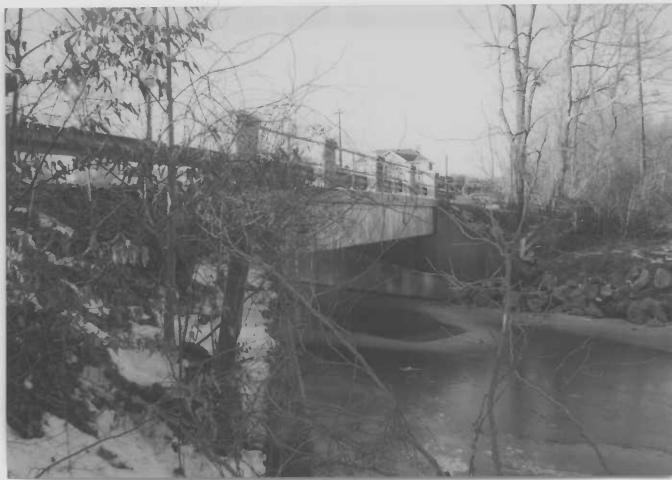
Name M21 - PINEY MEETINGHOUSE OVER WATTS BRANCH
County/State Monroomery mo
Name of Photographer FRANK JULIANO
Date
Location of Negative SHA
Description ExEVATION LOOKING WEST
1
4
Number <u>of </u>
